SIEGEL MARSH DAM

NDI No. PA 00015
PennDER No. 25-41

PHASE I INSPECTION REPORT NATIONAL DAM INSPECTION PROGRAM

Siegel Marsh Dam, Erie County, Pennsylvania
NDI No. PA 00015, PennDER No. 25-41
East Branch of LeBoeuf Creek
Inspected 13 May 1980

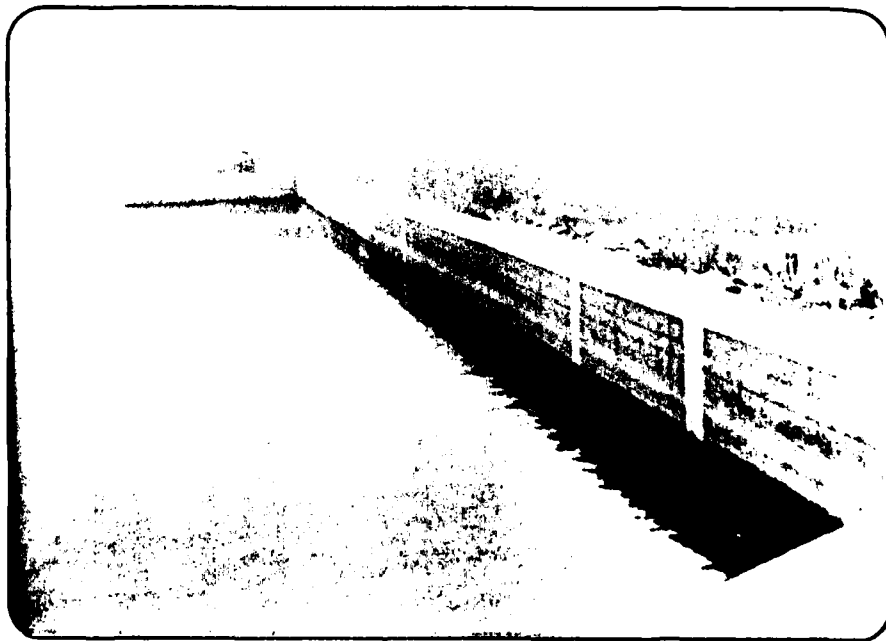
PHOTO 4. View of the Right Spillway from the Right Upstream Slope

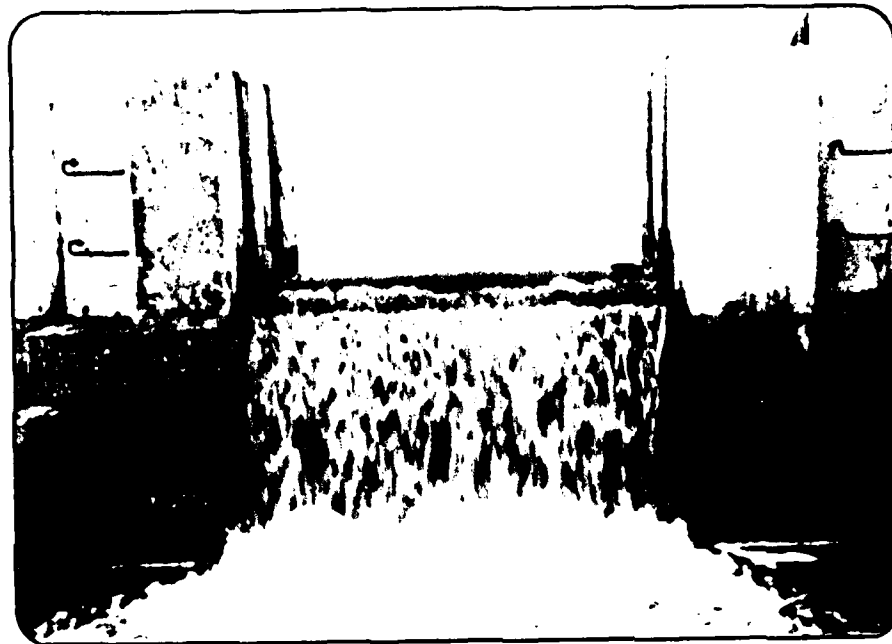
PHOTO 5. View of the Stoplog Structure from the Downstream Apron

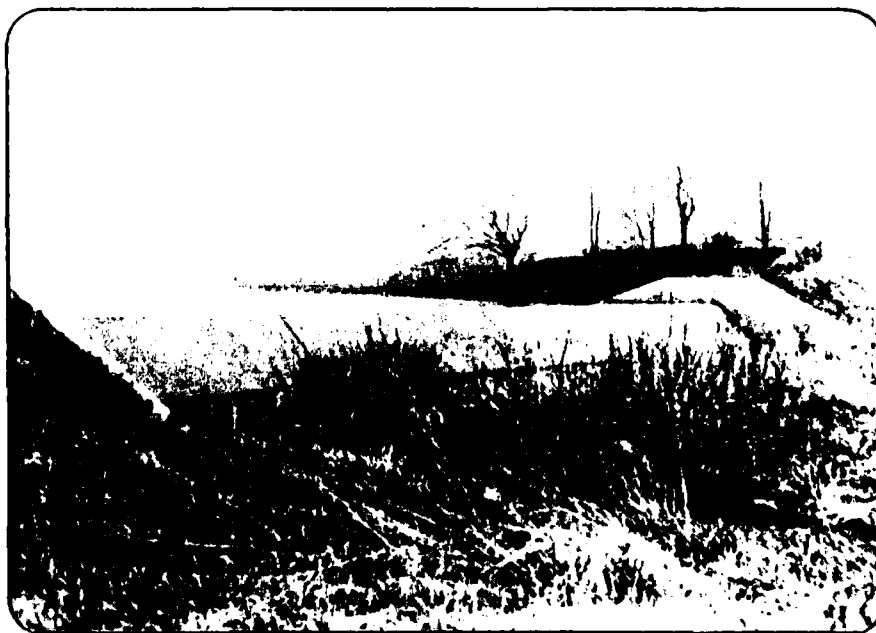
PHOTO 8. View Looking Upstream at the Left Spillway from the Right Downstream Side of the Structure

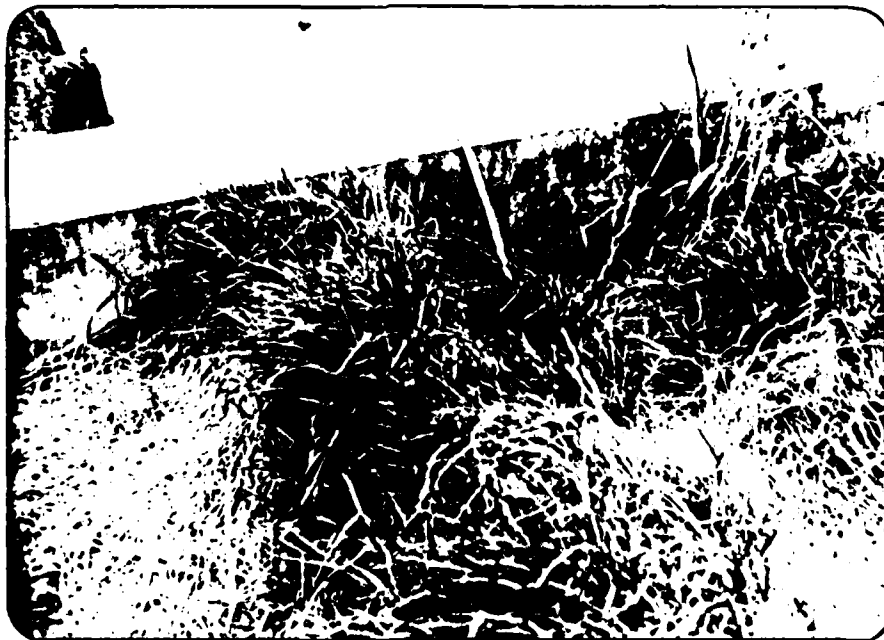
VISUAL EXAMINATION OF	OBSERVATIONS	REMARKS OR RECOMMENDATIONS
VERTICAL AND HORIZONTAL ALIGNMENT OF THE CREST	Low areas were observed at both junctions of the embankment and spillway training walls for the left spillway.	Fill the low areas to prevent concentration of run-off at these locations.
RIPRAP FAILURES	Riprap has been placed in the spillway discharge channels. No failures were observed.	
VEGETATION	The dam is well vegetated except for some minor erosion and tire rutting on the right embankment crest.	Fill the tire ruts and reseed.

Photo 10 - Typical View of the Low Area Adjacent to Left Spillway Training Walls

PHOTO 10. Typical View of the Low Area Adjacent to Left Spillway Training Walls
